NATIONAL PROGRAM FOR INSPECTION OF NON-FEDERAL DAMS
WEST SIDE DAM (CT 004..(U) CORPS OF ENGINEERS WALTHAM
MA NEW ENGLAND DIV FEB 81

REPORT DOCUMENTATION PAGE		READ INSTRUCTIONS BEFORE COMPLETING FORM
1. REPORT NUMBER CT 00484	2. GOVT ACCESSION NO.	3. RECIPIENT'S CATALOG NUMBER
4. TITLE (and Subtitle) West Side Dam NATIONAL PROGRAM FOR INSPECTION OF NON-FEDERAL DAMS		5. TYPE OF REPORT & PERIOD COVERED INSPECTION REPORT

WEST SIDE DAM
BLACKBERRY RIVER
NORFOLK, CONNECTICUT
CT 00484
17 NOVEMBER '80

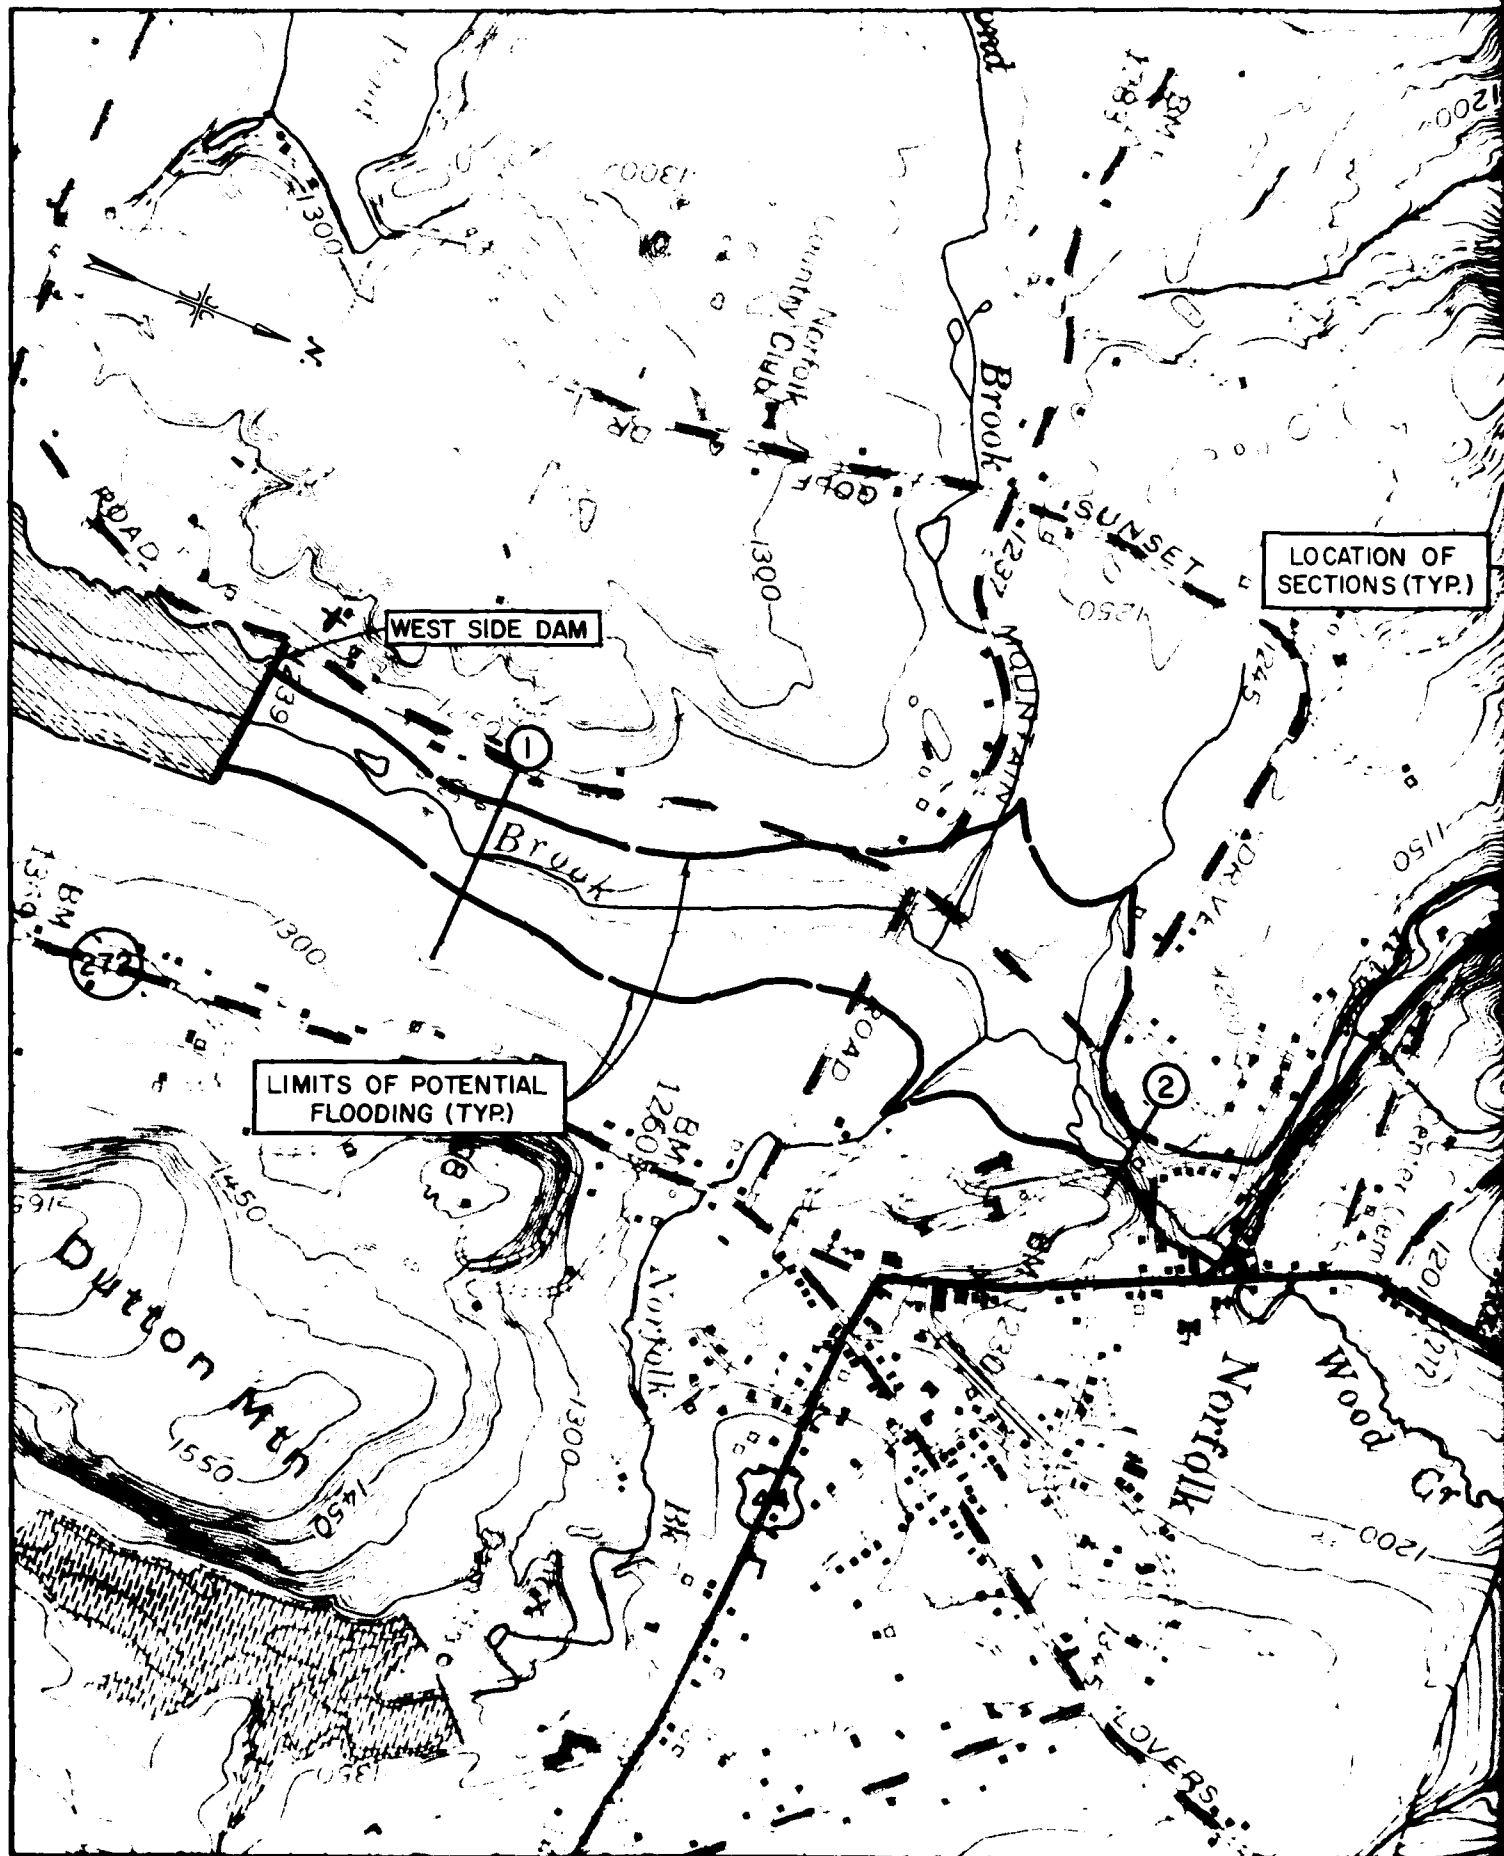
FIGURE 4

The calculated dam breach, 20 feet high by 240 feet wide, would release up to 28,000 cfs into Spaulding Brook. The flood waters would travel 1,200 feet downstream where a number of structures at a religious institution including a multi-family residence, a dining hall and farm buildings would be flooded up to a depth of 10 feet. The flood waters would continue downstream, overtopping a small dam by 9 feet, and flood several residential homes from 2 feet to 10 feet deep. The flood waters would join the Blackberry River and flow at an average depth of 9.5 feet. The low lying homes along the river banks would be flooded up to a depth of 2 feet. See Figure 4, page D-24.
